Engineering & Maintenance

Lucy's Mill Sluice Gate - Environment Agency

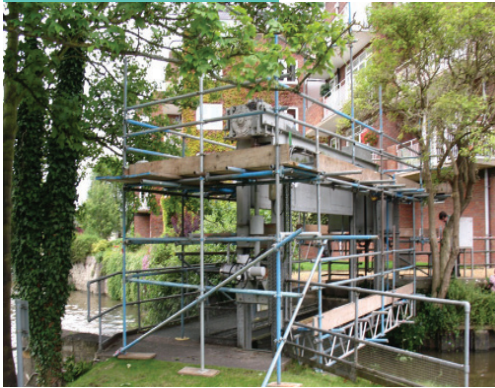
Before

Lucy's Mill Sluice Gate is an automatic flood control structure near Stratford Upon Avon. The gate was reported as inoperative which substantially increases the risk of flooding to the town centre and surrounding areas.

We were required to attend site immediately in conjunction with electrical contractors to diagnose the problem. The fault was found to be a failure of the mechanical gearbox mounted on the top of the structure. We were required to install a pull lift system to allow the gate to be lifted manually as heavy rainfall was forecast over the coming weekend.

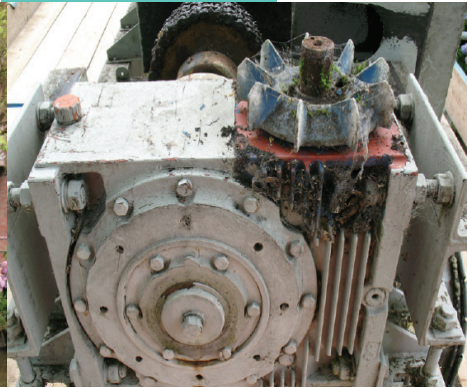
During

Due to the location of the gearbox scaffolders were immediately contacted to install a working platform around the sluice gate. Once in place we removed the drive shafts and inspected the gearbox which was found to be totally seized. The gearbox was removed and transported back to our Derby workshop facility where it was completely stripped and inspected. All the internal bearings were found to be in a poor condition with one in particular being completely seized. Parts were sourced locally to reduce cost and help in returning the gate into full operation as soon as possible.

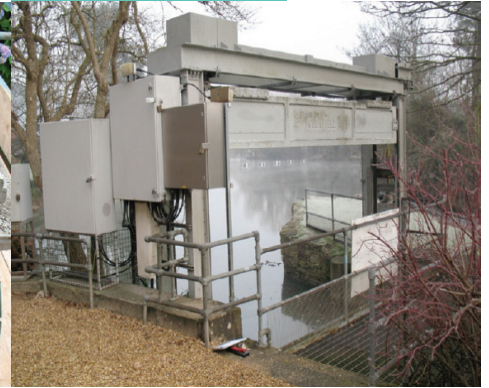
After

The gate was fully operational within a relatively short space of time with the customer very happy to be in control of the water levels on the River Avon.

On investigation of the fault we were able to identify that the gearbox was installed in the wrong position for its type. Although the position could not be altered we were able to advise a new preventative maintenance procedure to stop the fault re-occurring. Savings were made on the cost of parts sourcing locally rather than from the manufacturer.
